Research and conservation of historic decorative schemes in the built environment

Project Name: Decorative Schemes at Yr Ysgwrn

Client: Snowdonia National Park Authority

1.0: Outline brief & Method

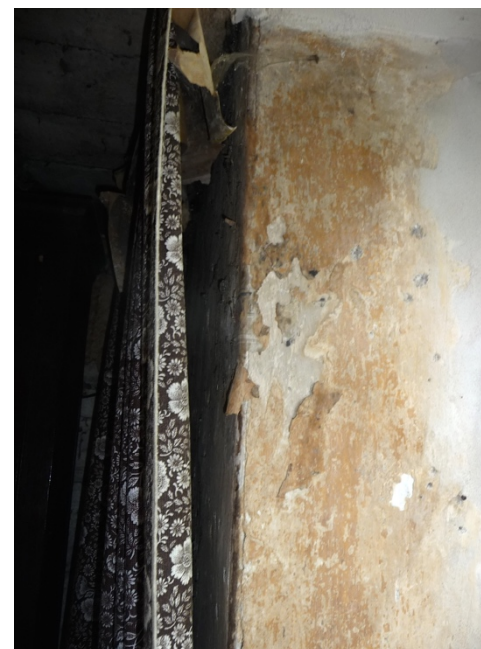
Fig.3: Traces of ochre distemper inside the window reveal

Behind the layers of wallpaper are traces of earlier ochre coloured distempers still clinging to the lime plastered walls.

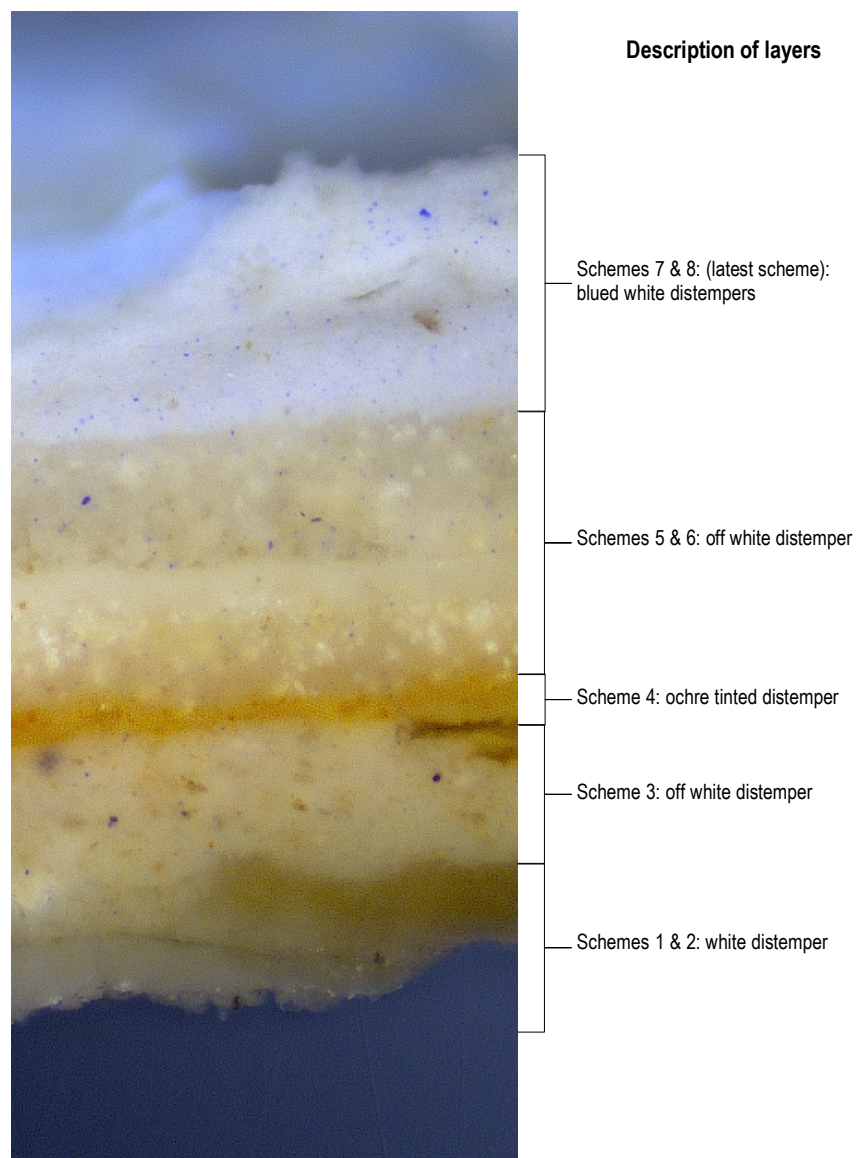
Fig.4: Sample 3.10 (X100) ceiling boards beneath lining paper

Image of the ceiling boards just in front of the window clearly showing the white distempers and traces of ochre tints.

The white distempers at the base of the sample are the earliest decorative scheme with the latest blued white distempers at the top of the image typical of the late C19/early C20. This suggests the earliest white schemes may be coeval with the mid C19 or possibly earlier.

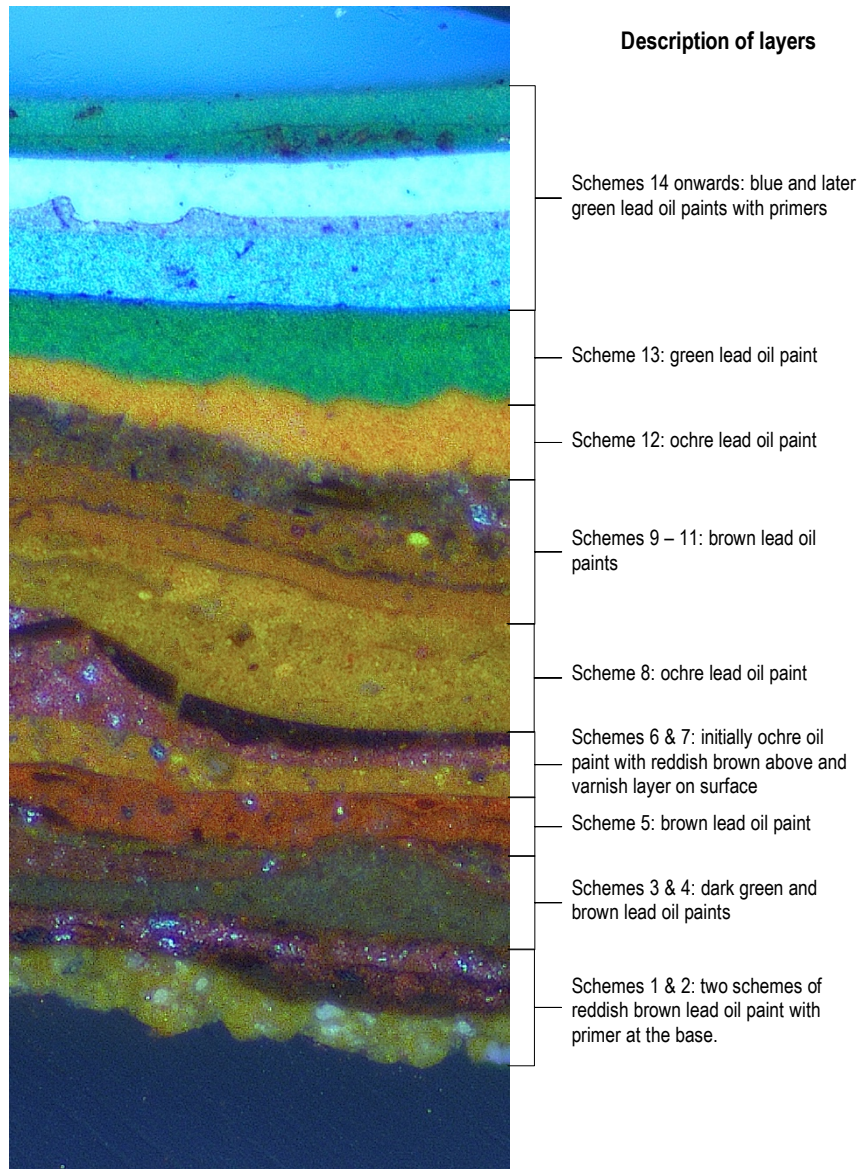
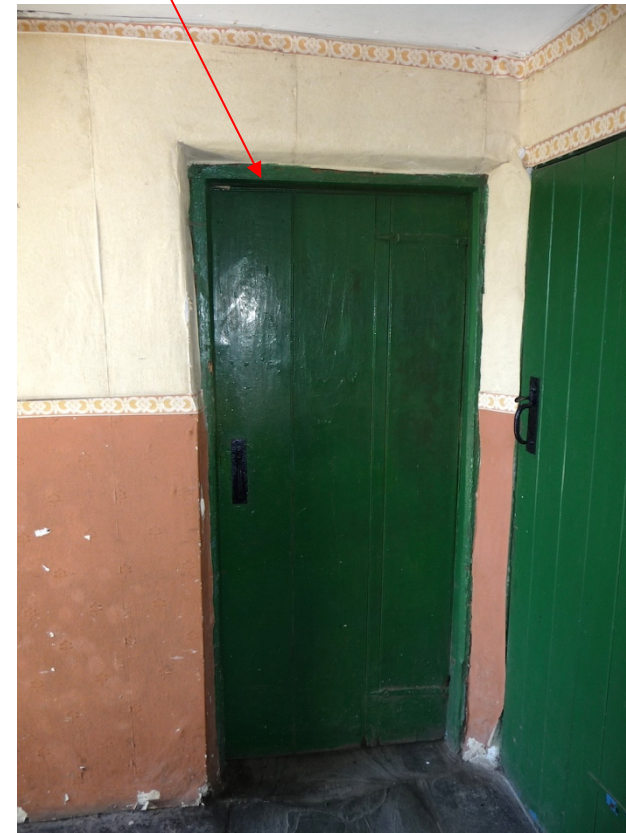
Fig.6: Sample 1.1 (X100) Entrance door frame

The sample cross section displayed left was removed from the entrance door frame into the cegin. The earliest schemes at the base of the image are a primer coat beneath two schemes in reddish brown lead oil paint. The subsequent decorative finishes are stacked above and annotated accordingly. Understandably, the samples removed from the door itself display an identical chronology and there is no evidence for the early decorative schemes being stripped from this area. It must be assumed schemes 1 and 2 are coeval with the 1st half of the C19. The sample removed from the

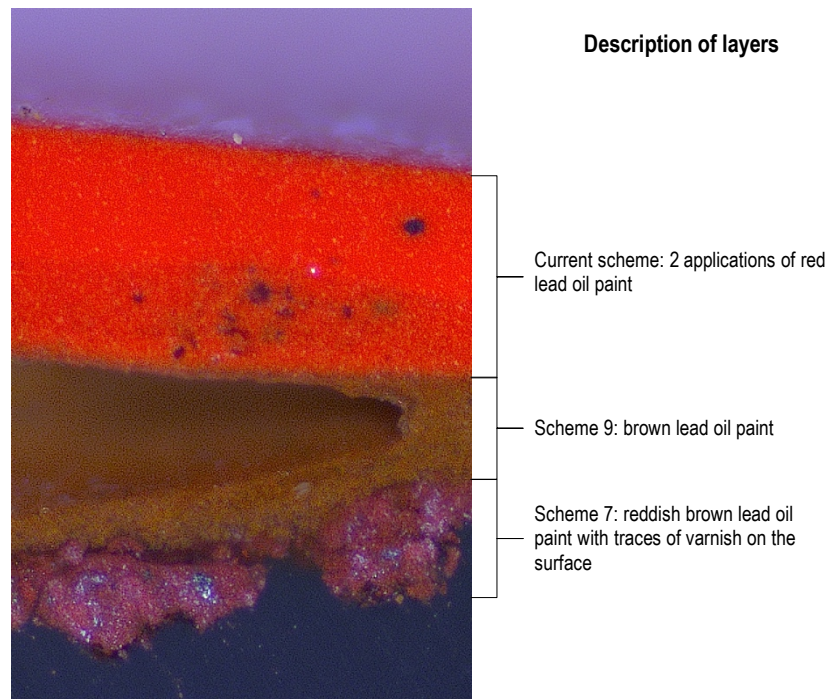
Fig.8: Sample 1.5 Entrance door inside face

The inside face of the door has been stripped on three occasions in the past. The early layers (schemes 1 to 6) are missing completely and were cleaned off prior to the application of scheme 7 in reddish brown. This layer directly corresponds to scheme 7 on the outside face of the door. The surface was cleaned back again prior to the application of the brown oil paint at scheme 9 and again before the current red was applied.

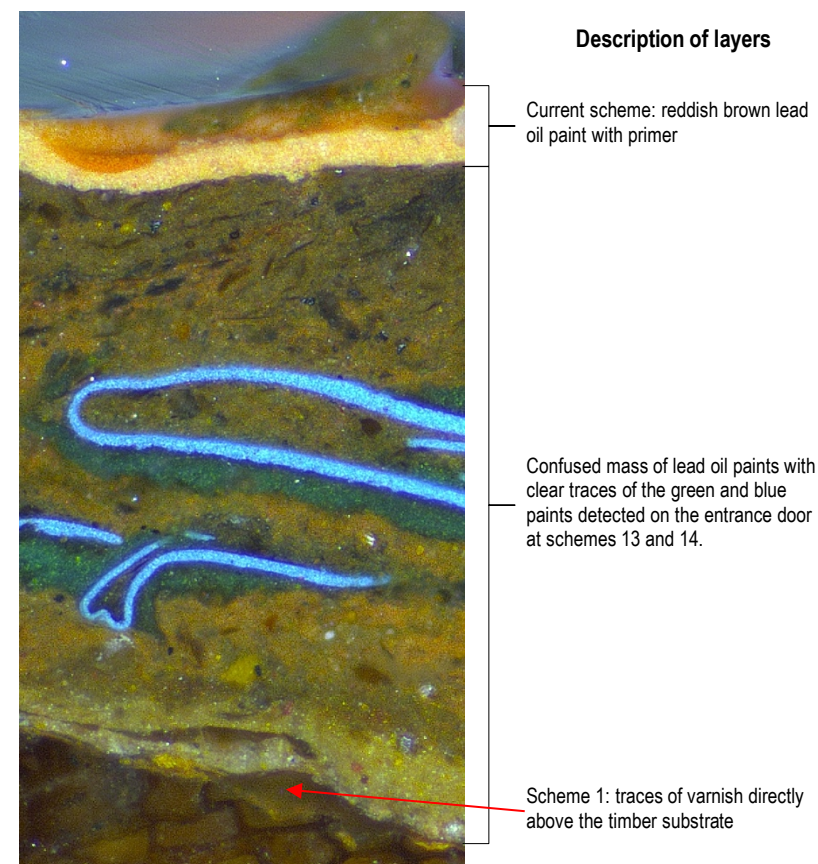
Fig.9: Sample 2.7, The Window Seat

The window seat appears to have been heat stripped prior to the application of the current paint scheme leaving the earlier paints in a confused mass and out of context. However, there are clear traces of a natural resin varnish layer directly above the timber substrate that was in place for some considerable time and should be considered the earliest defined decorative scheme throughout the C19 and into the C20.

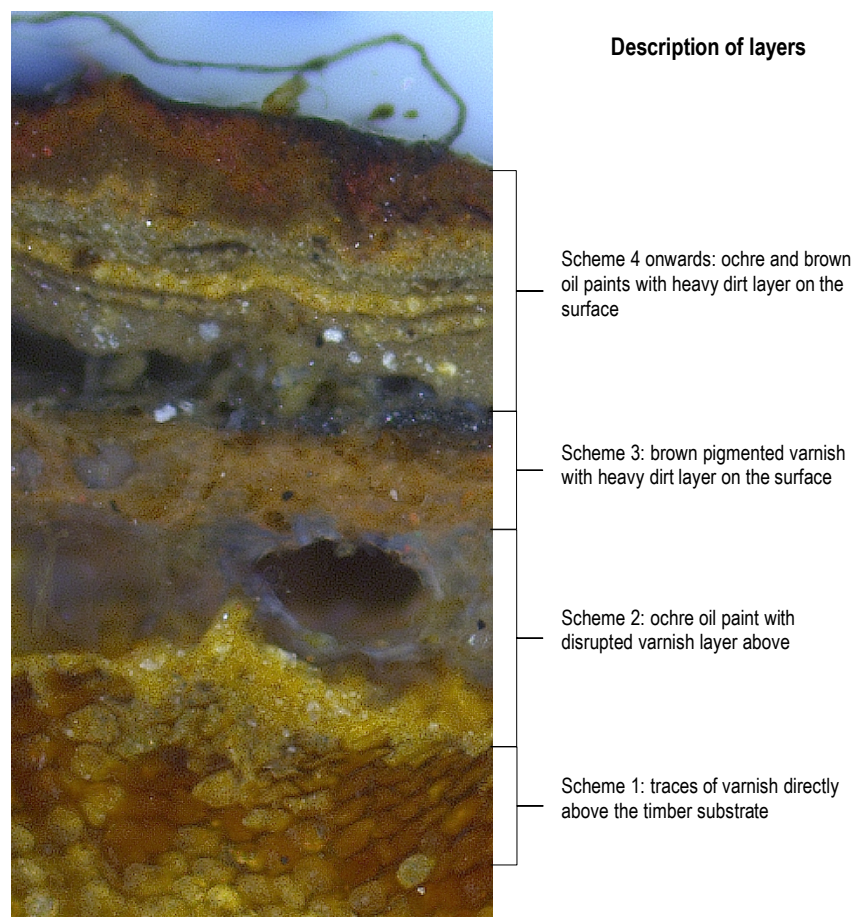
Fig.10: Sample 2.6 Wooden mantelpiece

The mantelpiece has not been painted for a considerable time with a very heavy blackened dirt layer on the surface. There is trace evidence of an early varnish directly on the timber substrate and as is the case with the window seat, this should be considered the earliest decorative scheme. Subsequently the surface was cleaned, painted in an ochre oil paint and again varnished. Another varnish was applied at scheme 3, but in this instance pigmented dark brown and has a very heavy sooty dirt

layer on the surface. Subsequent schemes were applied in ochre and brown lead oil paints and all have sooty deposits accumulated on their surfaces.

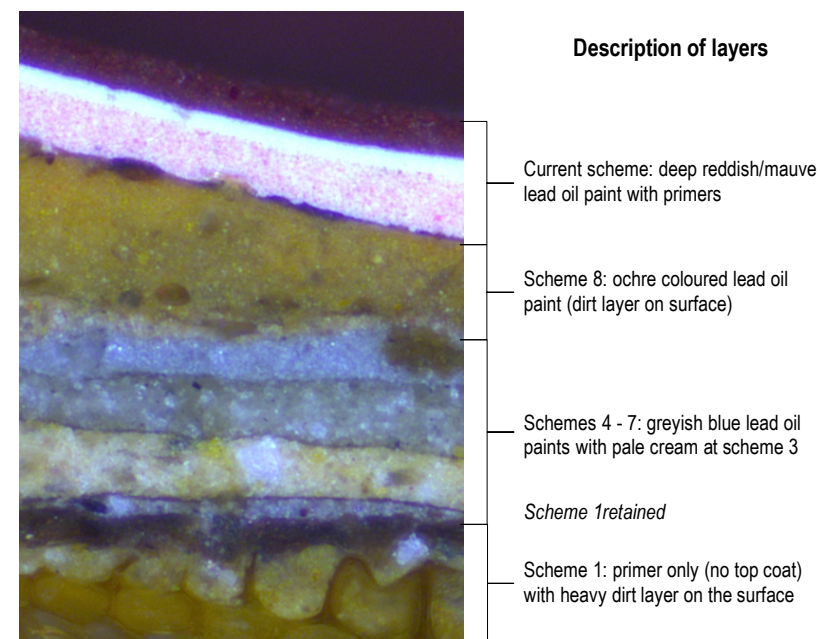
Fig.11: Sample 2.8 Door to Maid's Room

The earliest paint scheme on the door to the maid's room facing into the cegin was simply an ochre coloured primer with no top coat applied, which was retained until scheme 4, hence the heavy layer of dirt accumulated on the surface. Subsequent lead oil paints were applied in greyish blue, pale cream and ochre prior to the application of the scheme we see today in deep reddish mauve.

It is interesting to note there are two doors facing into the cegin and both are currently painted in different colours. Furthermore there is only one historic paint scheme corresponding on both doors (the ochre at scheme 8), although it should be noted the inside face of the entrance door has been cleaned back in the past with the corresponding ochre on the outside face of the entrance door (fig.6). This suggests the two doors have a history of predominantly being painted differently or one of them has been moved from another location into the cegin. However, both doors are of identical construction and have the same strap hinges without any evidence of scarring where earlier fittings may have been removed or otherwise adapted. This suggests the Maid's Room door is an original feature that was initially simply primed and left for a long period of time without a top coat, prior to being painted in greyish blue and later cream.

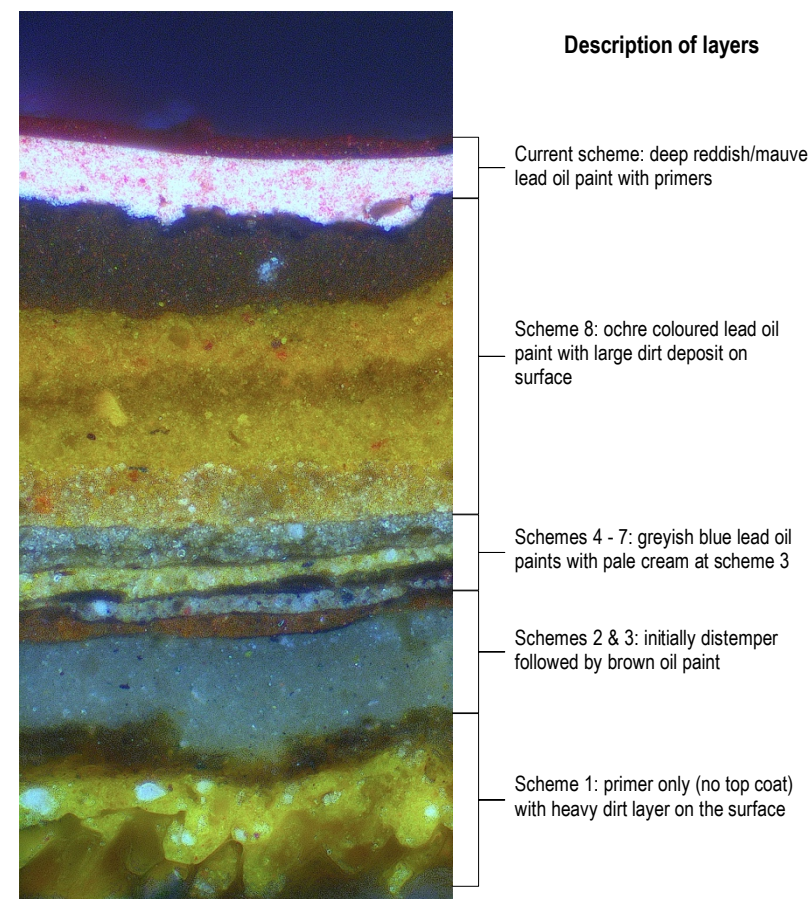
Fig.12: Sample 2.9 door frame to Maid's Room

The microscope image opposite (fig.12) is the sample removed from the door frame to the Maid's Room. Compared to the door there is an identical primer at the base (scheme 1) with a layer of dirt on the surface. Above this are two further schemes not evident on the door itself (initially in distemper followed by a brown oil paint) suggesting they were painted in isolation. The distemper may be a residue left on the door frame when the walls were distempered and if so, pre-dates the wallpapers in the cegin. The subsequent layers in greyish blues and creams match the corresponding paint layers on the door itself, up to the now familiar ochre oil paint at scheme 8.

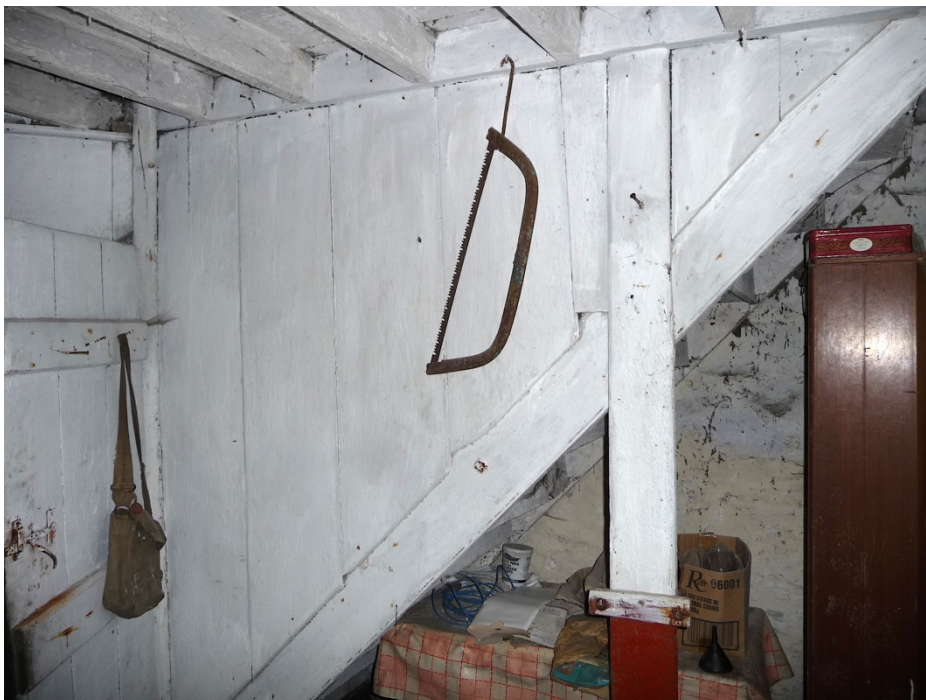
2.2: The Buttery & Pantry Area (fig.13)

This area is currently uniformly painted in soft white distempers overlaid in some areas with a modern alkyd paint. There are traces of blues and cream/ochre evident in some areas beneath the surface. Samples were removed from both the walls and timber panelling with both displaying an identical paint chronology. The earliest evidence is a blue distemper, followed by several ochres, blued whites and finally white.

Note: it is impossible to define the number of coats applied; distempers are essentially chalk and pigment carried in animal glue. Each successive distemper application reactivates the glue binder in the layers beneath causing them to merge and appear as a single mass.

The walls in the buttery/pantry have several layers of thick distempers in whites, blues and ochres and doubtless would have been frequently refreshed to maintain and present a clean environment suitable for food preparation and storage.

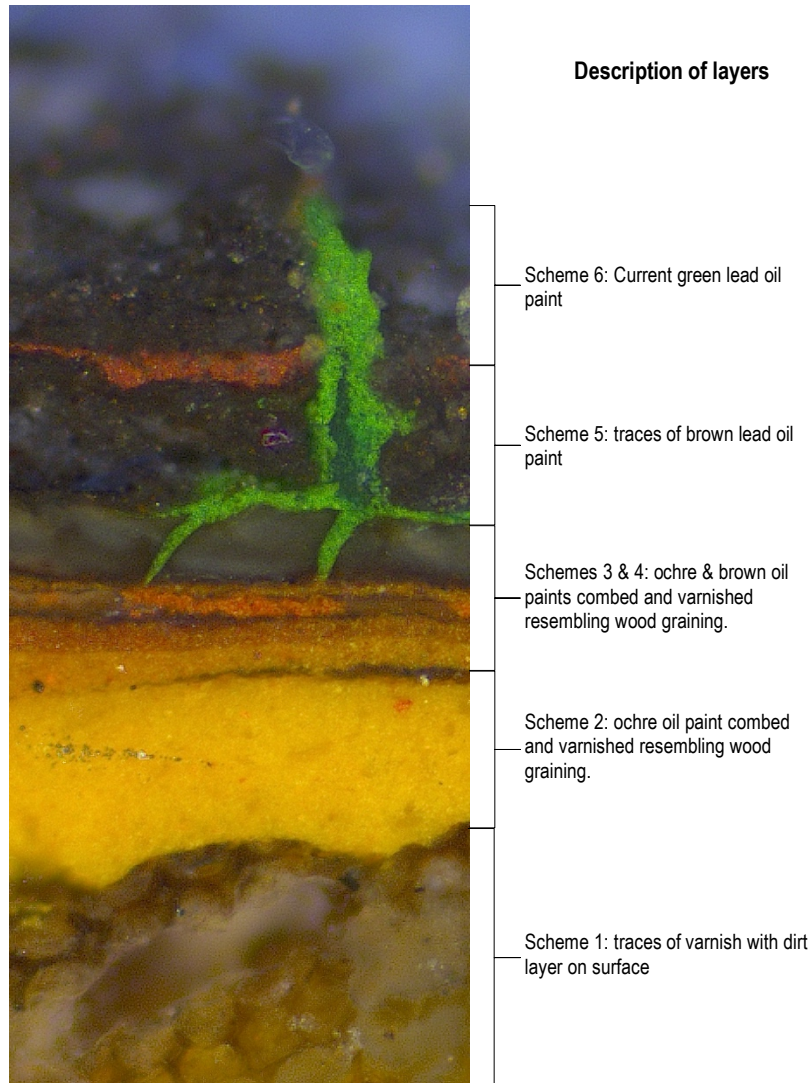
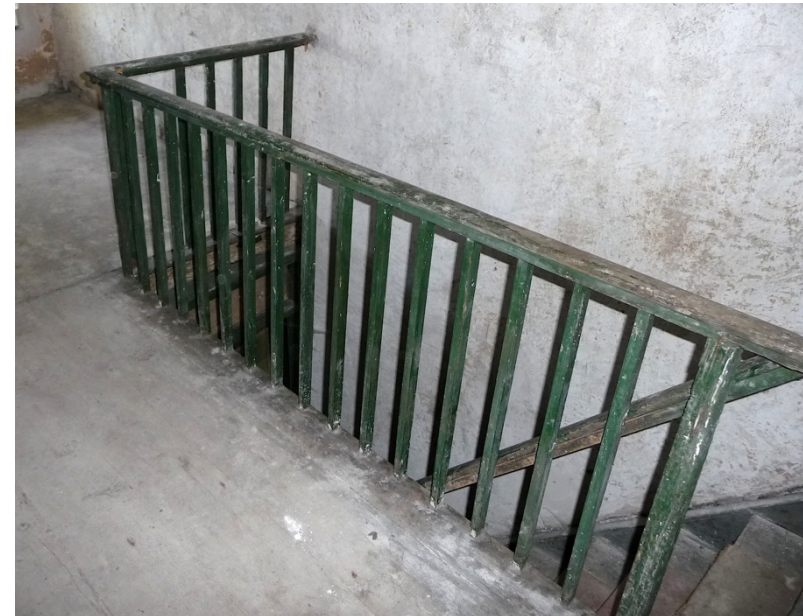
Fig.15: Sample 4.14 stair spindles

The earliest decorative scheme on the stair spindles is a varnish with a surface dirt layer. Following this are three schemes of ochre oil paint with a brown oil paint combed onto the surface and varnished to resemble wood graining. These three combed schemes appear to date to the mid to late nineteenth and into the twentieth century. Above the combed layers are traces of brown oil paint with the current green scheme visible above. The upper layer (in green) was applied to an extremely degraded and dirty surface and has flowed down beneath the brown oil paint and is embedded into the varnish layer at scheme 4. This suggests the combed decorative effect was left in place for a considerable time prior to being painted out in brown lead and later green oil paints.

Moving upstairs; the green paint applied to the stair spindles appears to be coeval with the green paint detected elsewhere throughout the farmhouse and on the door at Beudy Llywd, with strong evidence for the earliest decorative scheme being combed and varnished to resemble wood graining. Further varnishes were found on the doorframes on the landing dating to the same period, but not on the doors themselves. The bedroom walls also have an accumulation of distempers with traces of later wall papers still clinging to the surface in isolated areas.

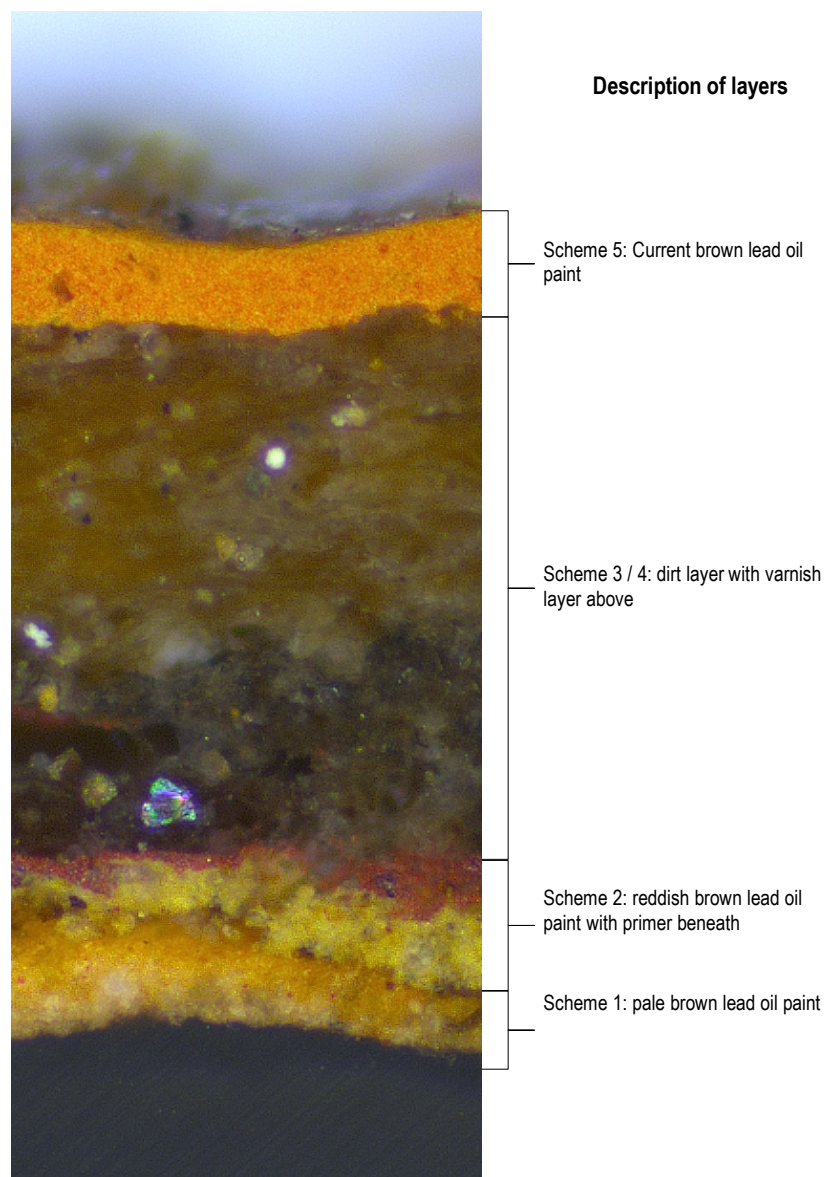
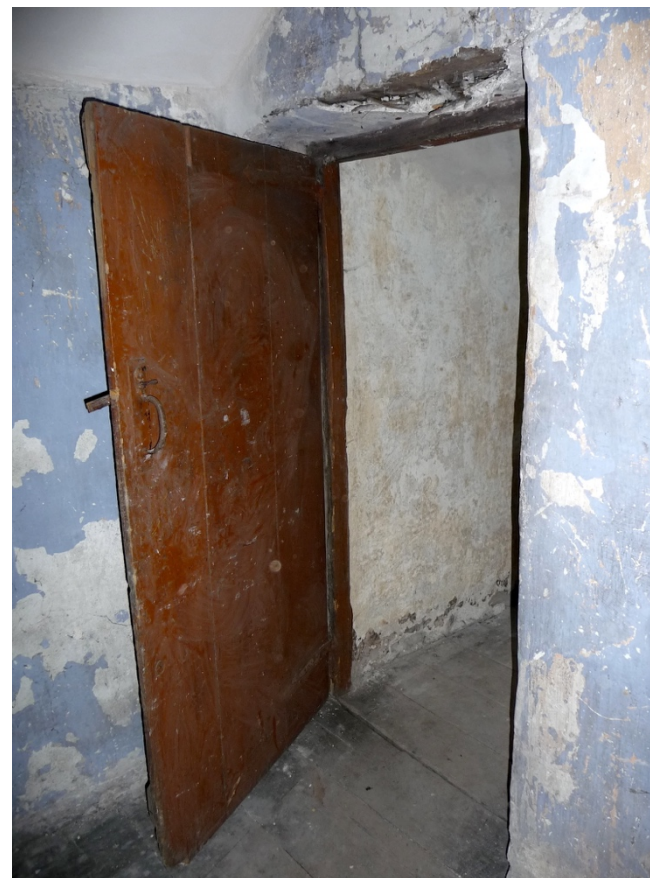
Fig.17: Sample 4.15/16 Door & door frame into blue bedroom

The sample left (fig.17) was removed from the door frame facing into the landing. Samples removed from the door itself are identical but lacking the varnish layers at scheme 3 / 4. It is therefore likely the painted door frames on the upper floor were varnished with the combed wood graining on the stair spindles (without combing). The reddish brown at scheme 2 corresponds to the same colour scheme detected at

scheme 2 on the entrance door frame to the cegin. An identical paint chronology was also detected on the window seat in the bedroom (see fig.19 below).

bedroom doors appears to be identical to the same colour detected at scheme 2 on the door leading into the cegin and pre-dates the Hedd Wyn period. It therefore remains a possibility the current brown scheme is coeval with the early twentieth century and bears witness to the Hedd Wyn period of occupancy.

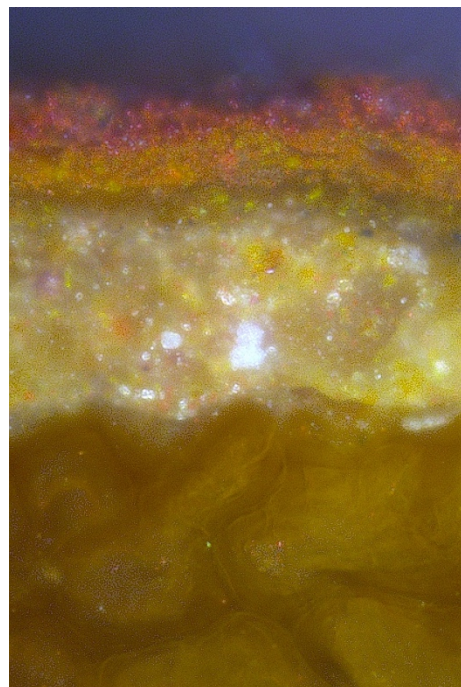
Fig.19: Sample 4.18 window seat, blue bedroom

Two schemes of lead oil paint in pale brown and reddish brown. Identical to the bedroom door and doorframe.

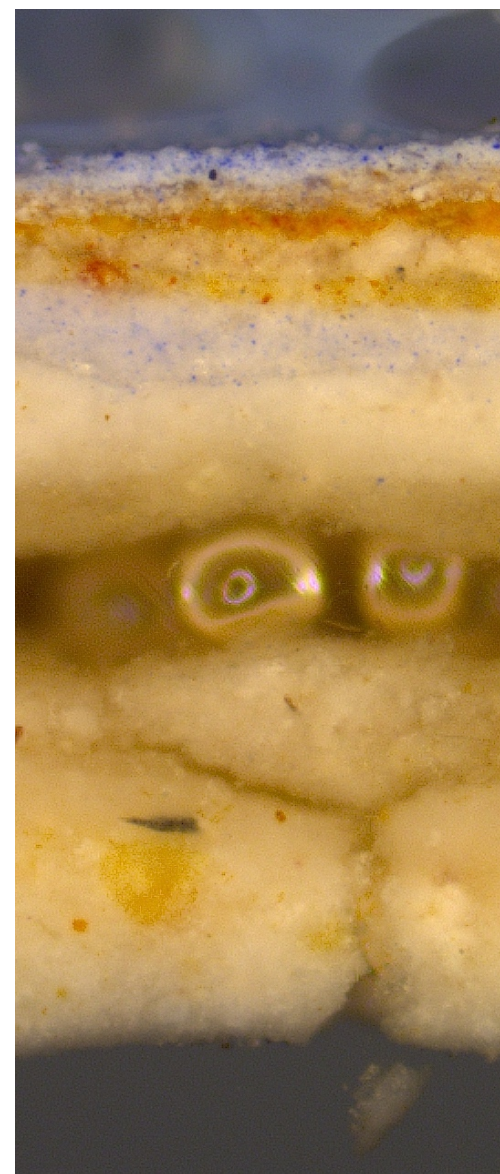
Fig.19: Sample 5.19 Bedroom Walls

Scheme 9: blue distemper

Schemes 5 – 8: ochre distempers

Scheme 4: blue distemper

Schemes 1 – 3: pale ochre and off white distempers

The bedroom walls retain an early lime plaster with several coats of soft distemper immediately above. Initially in pale ochre and off white, then blue with further ochres and finally the strong blue we see today.

Virtually all traces of wallpaper have been stripped from the walls of both bedrooms, leaving evidence of a blue distemper on the lime plastered surface, with further ochres and blues beneath. It must remain conjectural as to whether the walls were papered at this time or whether the blue distemper was in place during the early twentieth century.

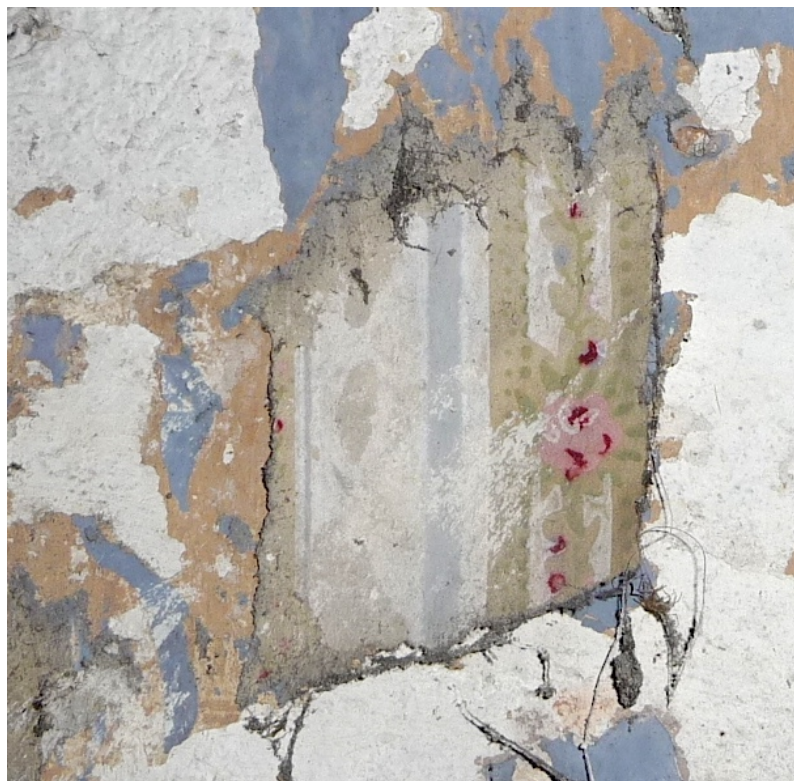
Fig.20: Wallpaper fragment, blue bedroom

There are traces of wallpaper still clinging to isolated areas of the surface, but these fragments are too small to be able to define a pattern repeat (see fig.20). Furthermore, a comparison with the wallpapers recovered from the cegin does not reveal an identical paper.

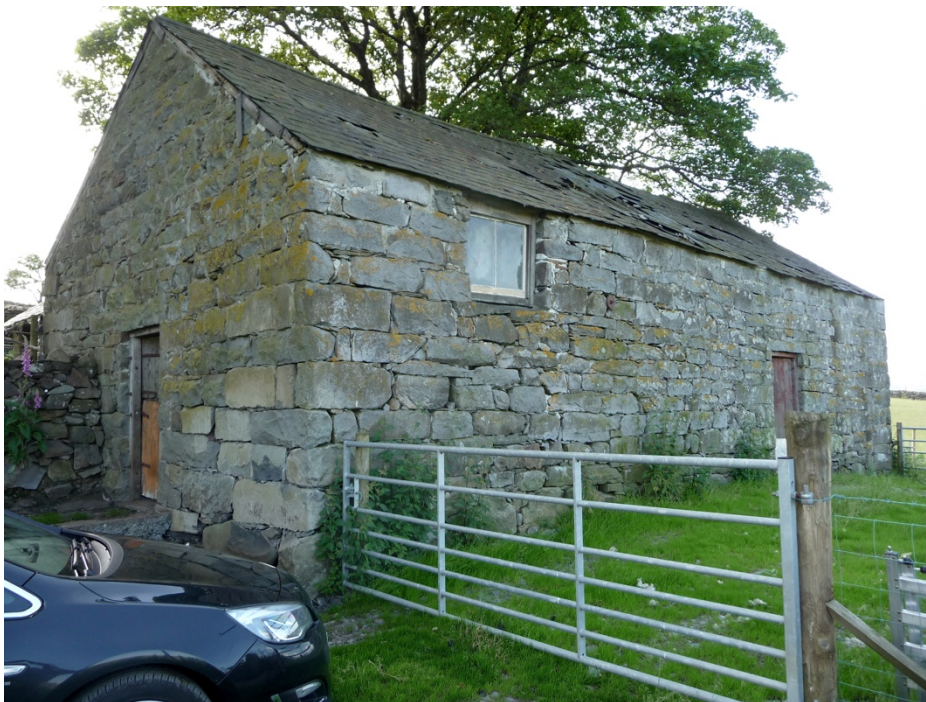
2.4: Fig.21 Beudy Llywd

Beudy Llywd is a remote barn set apart from the main complex of buildings surrounding the farmhouse and is sited adjacent to the main access road. The barn is currently in a dilapidated state with limited potential for the analysis of historic paint schemes and for this exercise sampling was focussed on the two doors shown in the above image. Both have clearly been repaired and altered over the years, primarily with replacement vertical planking and corresponding horizontal battens on the inside faces to maintain structural integrity. Two samples were removed: a trace of green paint on the inside face of the west facing door and the red paint on the outside face.

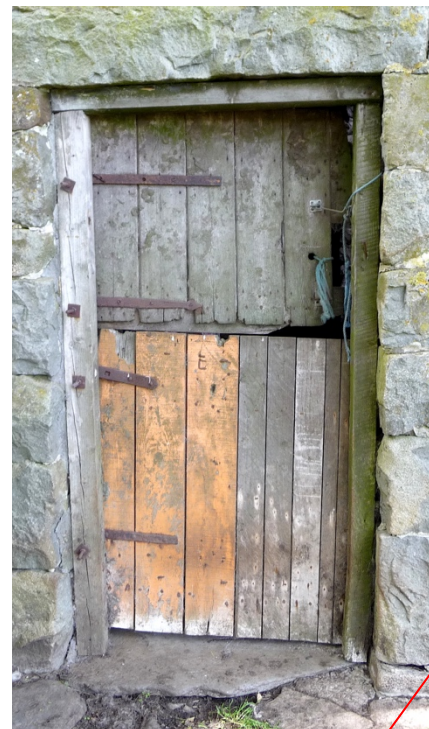
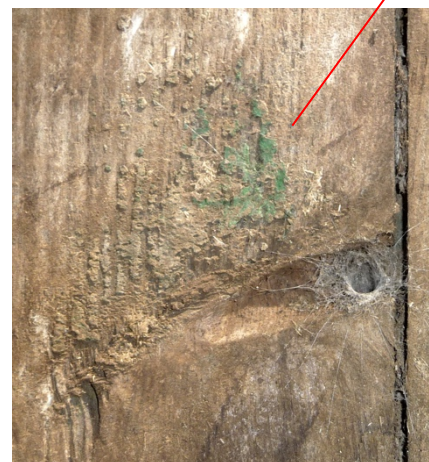
Fig.22: North facing door (external)

Traces of green oil paint clinging to the surface of the original section of the door. The blue painted planking is clearly a later repair and considered out of context.

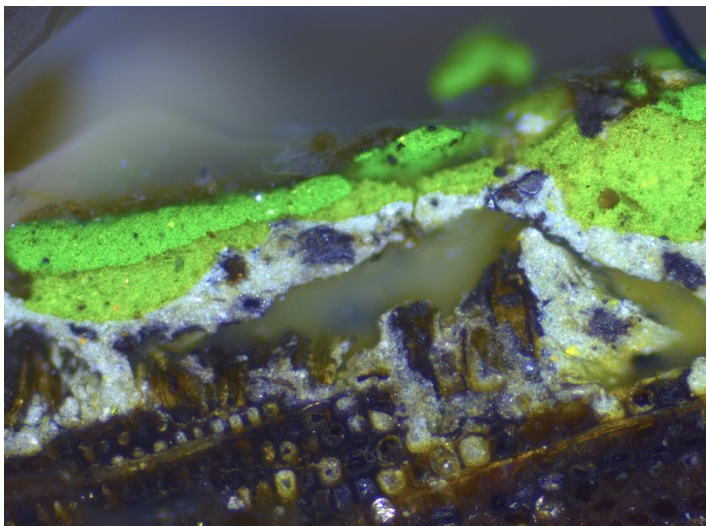
Fig.24: Sample 6.25 west facing door (inside)

The inside face of the door has a coarse grey lead primer at the base with a green lead oil top coat that was subsequently re-painted once in the same green.

This appears to be identical to the greens detected inside the farmhouse and is likely to date just after 1945.

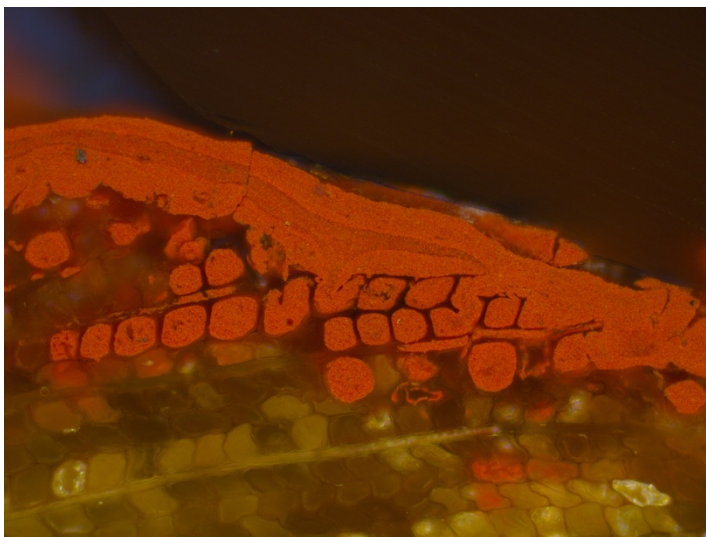
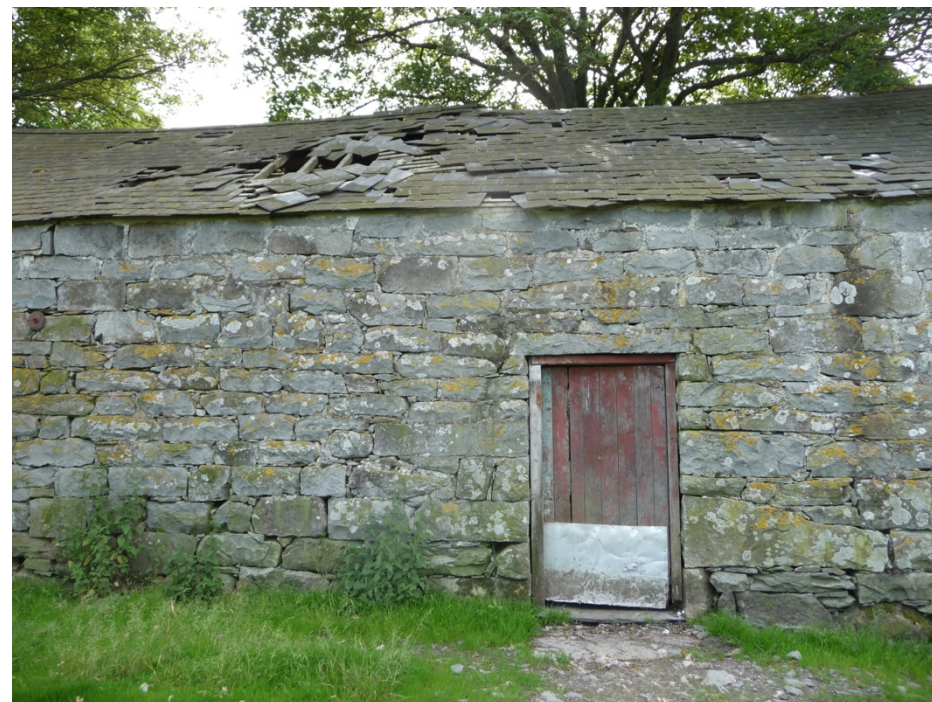
**Fig.25: Sample 6.23 west facing door (outside)**

The outside face of the door (see fig.26) has no primer and has been painted three times in red lead oil paint. Potentially, this could be the same paint used on the inside face of the door into the cegin.

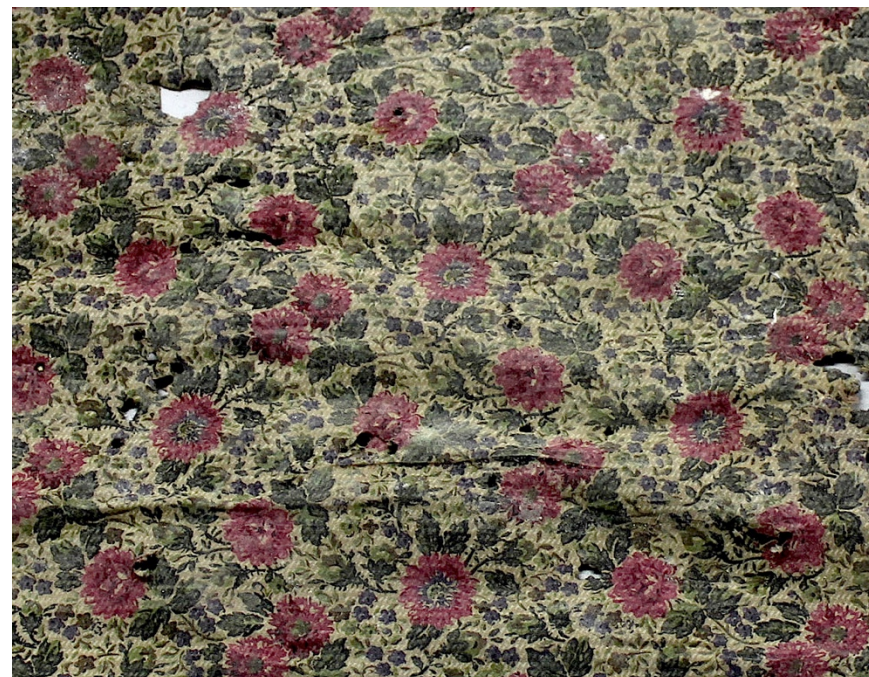
Fig.28: Floral wallpaper (cegin) potentially coeval with the Hedd Wyn period

papers hung in the cegin are reported separately with a busy pink and green floral paper dating to the 1900 – 1914 period (see fig.28 below).

It seems probable that the paper in place during the 1914-1918 period was layer ref. 10u, the pink and green floral pattern. Although this has no makers information on the selvedge, it pre-dates the 1918-1919 layer (10t) and would therefore be the most likely candidate for the First World War era. There is sufficient wallpaper available in this design to make it possible to re-create this pattern.

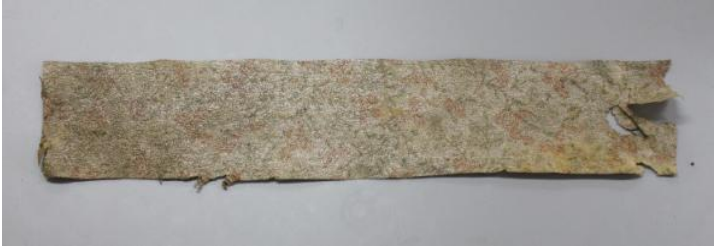
<p>IMG_0347</p>	10c	Embossed paper. Possibly floral design overlaid with pearlescent 'swirls'.	'E' on selvedge. c. 1950s-1960s.

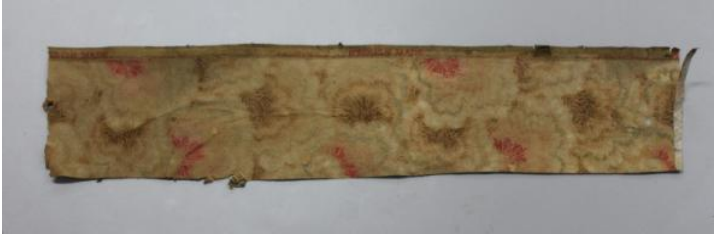
<p>IMG_0348</p>	10d	Fan/firework-like pattern in reds, greens and browns.	'English Made' on selvedge. c. 1950s

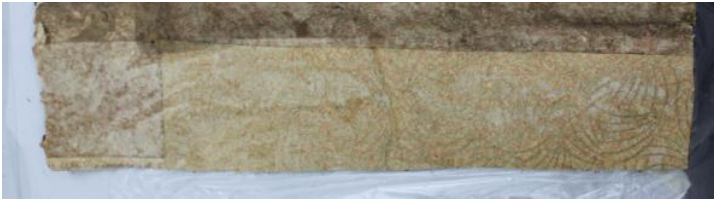
<p>IMG_0346</p>	10e	Multi-coloured background overlaid with green lines in a fan-like arrangement.	c. 1950s

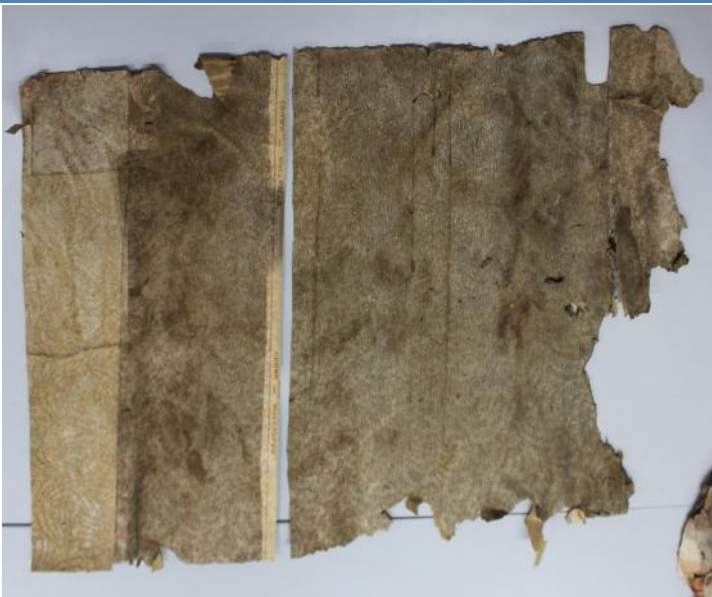
10f	Indistinguishable curvilinear design. Once a light background.	Very dirty. Crown wallpaper sedge. Dating problematic due to condition of wallpaper. Possibly c. 1940s. Further research could be carried out into sedge and pattern design.

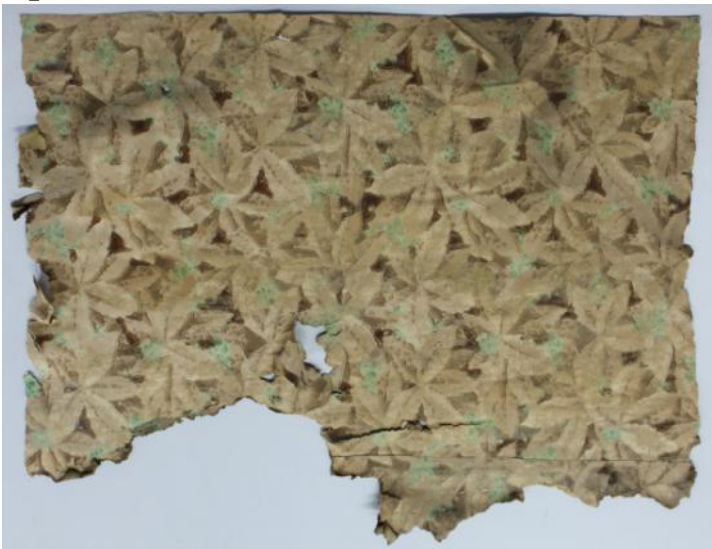
10g	Abstract palm leaf design in browns and green.	Crown wallpaper sedge. c. late 1930s

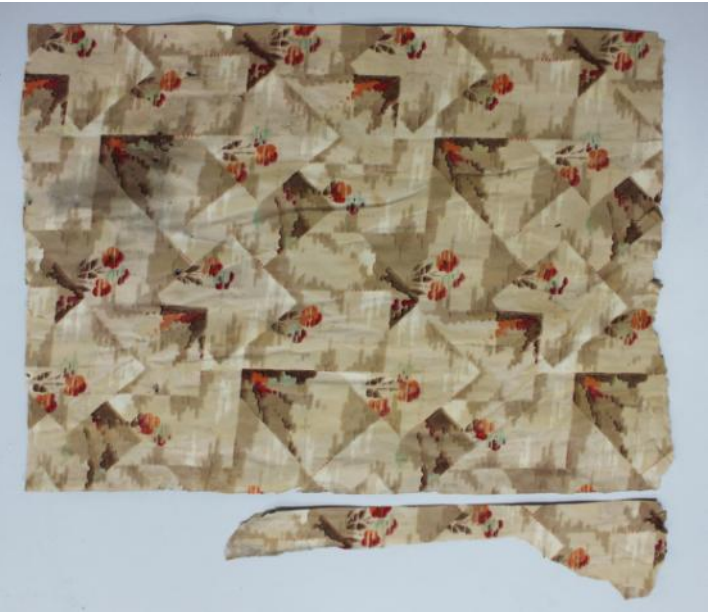
IMG_0368	10j	Multi-buff background with diamond pattern and stylised poppies in red and green.	Selvedge removed. c. 1934

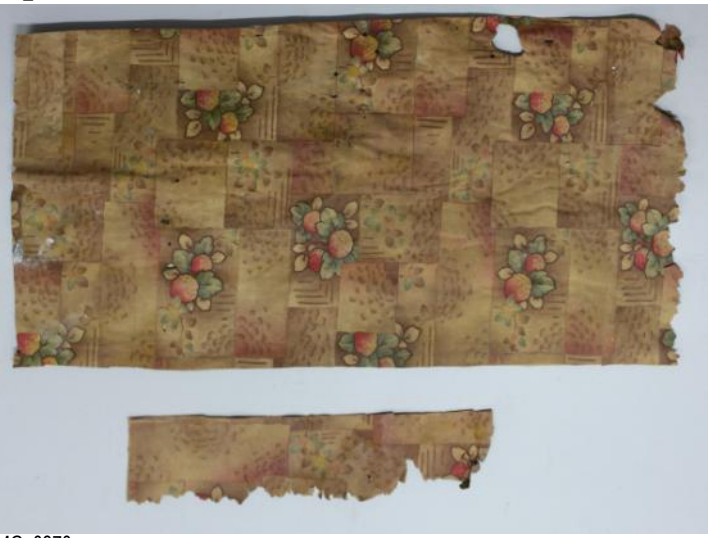
IMG_0370	10k	Multi-brown background with squares. Repeating motif of fruit with heavy outlines.	Selvedge removed apart from very small partial section (IMG_0372) – probably reads 'Reg ^d No', but number itself not present. c. 1933

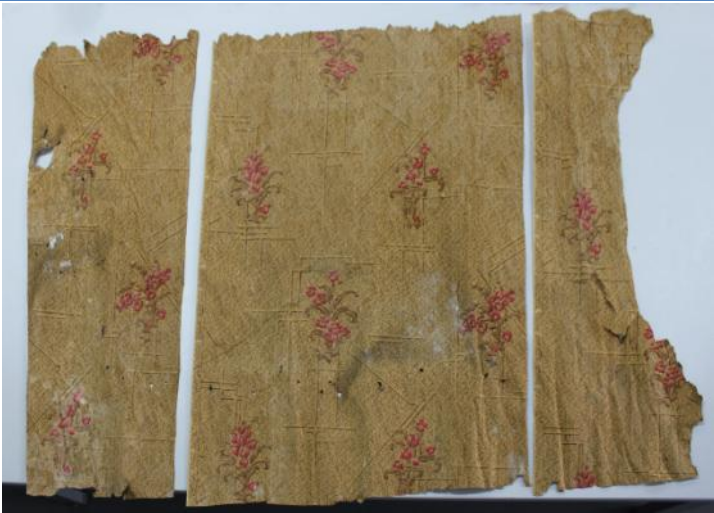
IMG_0374	10l	Light brown ground. Geometric lines with artificial embossed effect, and red flower motif in a 'Chinese' type style.	Crown wallpaper selvedge (IMG_0376). c. 1931-32

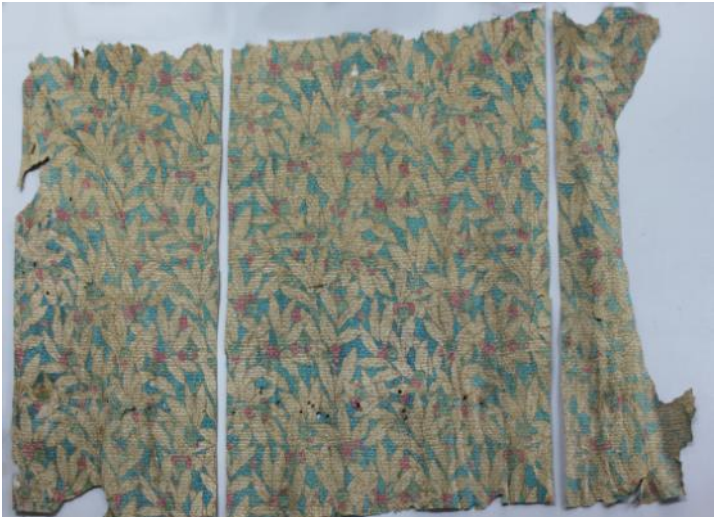
IMG_0378	10m	Abstract leaves and red berries on a light turquoise-blue ground.	Selvedge removed. c. 1930

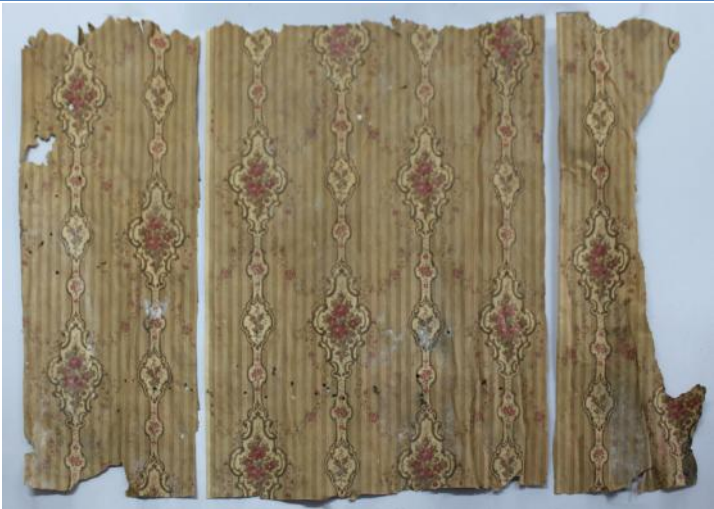
<p>IMG_0380</p>	10n	Broad brown pinstripes with rose-filled cartouche and interconnecting flower garlands.	Selvage has three circles, but no text. c. 1929-30

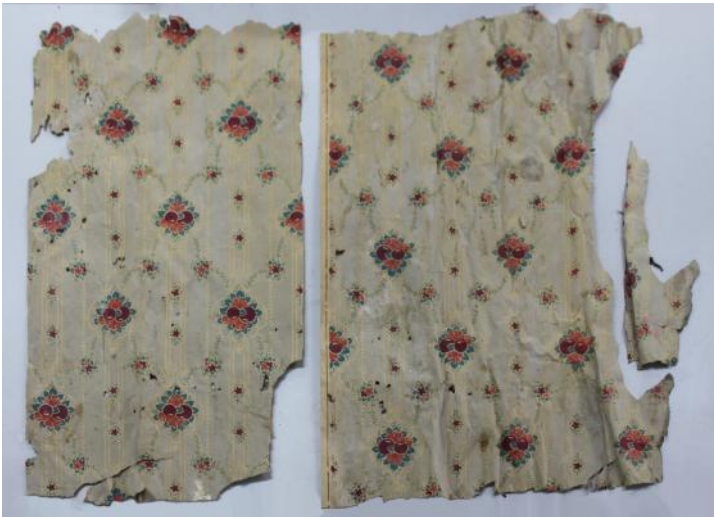
<p>IMG_0388</p>	10o	Light coloured ground with outlined cartouche in cream/yellow, filled with fruit and flowers.	Selvage (IMG_0384): English Made R ^D 736323. 3-4 layers thick in places. Design registered in 1928

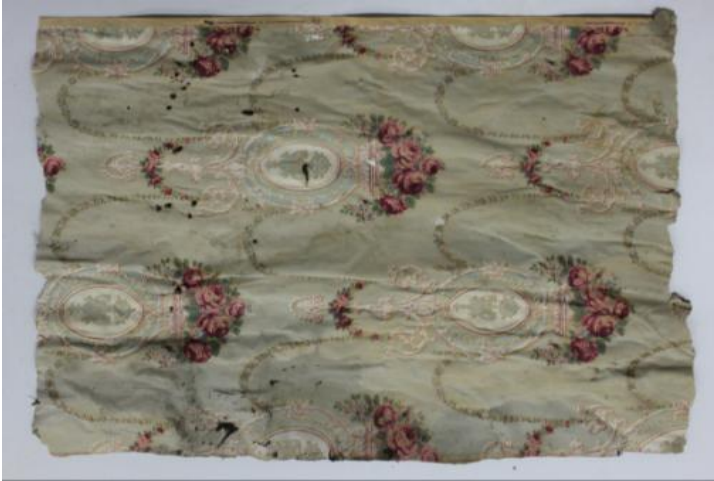
IMG_0394	10q	Light ground with elaborate flower cartouche and floral garlands.	Very dirty. Elaborate stylised, mirrored 'E' on selvedge. c. 1922-23

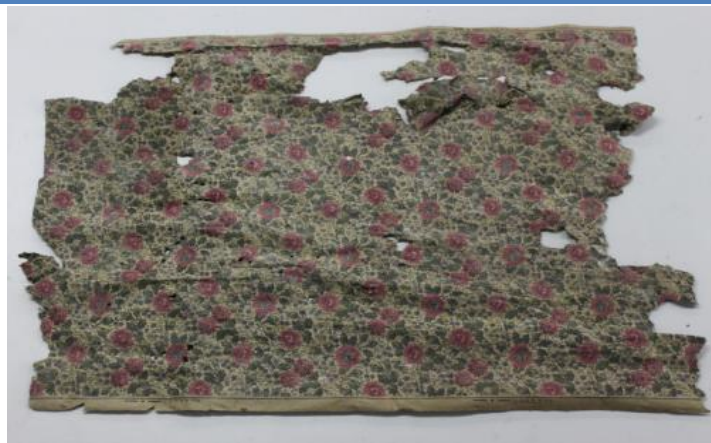
IMG_420

Busy pink and green floral pattern. 21.5 inches wide in total (including both selvedges). 20 ³/₄ inches pattern width.

Selvedge (IMG_0421) has circles but no text. Pre 1918. Probably c. 1900s – 1914.

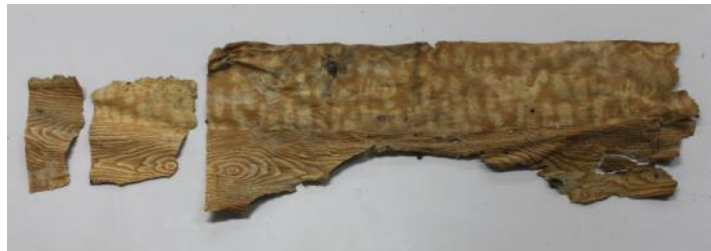
10v

Woodgrain effect.

Woodgrain style paper was produced over a wide range of dates, with very little variation in pattern, which makes dating complex. Probably 1890s-1910s, pre-dates layer 10u.
